Building Analysis Report

Inspector: Richard P. Thacker, CRI 10-9779

Site Location: 555 Main Street

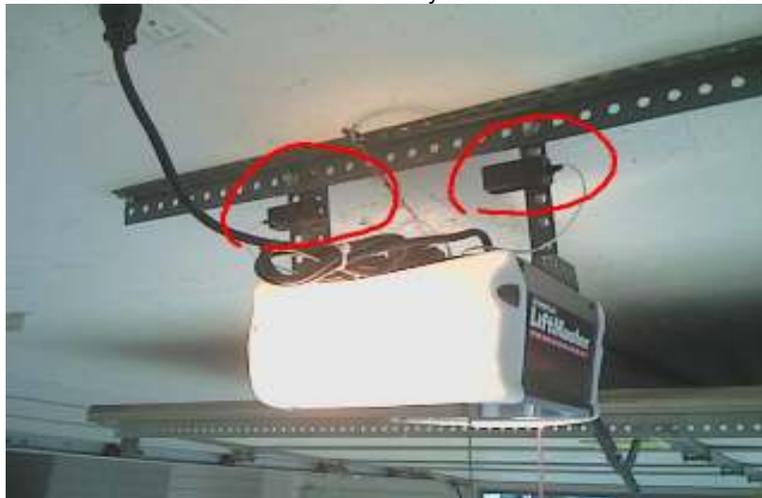
Opener: Automatic
Conditions: **Unsafe installation of auto reverse device ---** The electrical device appears to be installed improperly and/or in an unsafe manner. Further evaluation by an electrician is recommended.

Unsafe installation of auto reverse device --- The electrical device appears too installed improperly and/or in an unsafe manner. Further evaluation by an electrician is recommended.

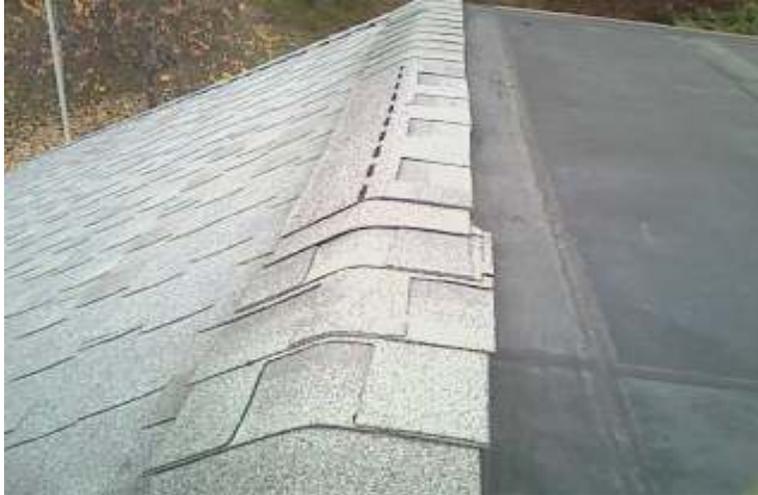
Location: RIDGE CAP REPAIR

Conditions: **Poorly patched** --- Patched area. The area is subject to further leaks and should be properly repaired by a competent contractor.

Poor workmanship --- The quality of work does not appear to be what is generally considered acceptable from a professional. Have the workmanship evaluated and corrections made by a competent specialist.

Condition: Poorly patched - Patched area. The area is subject to further leaks and should be properly repaired by a competent contractor.

Condition: Poor workmanship - The quality of work does not appear to be what is generally considered acceptable from a professional. Have the workmanship evaluated and corrections made by a competent specialist.

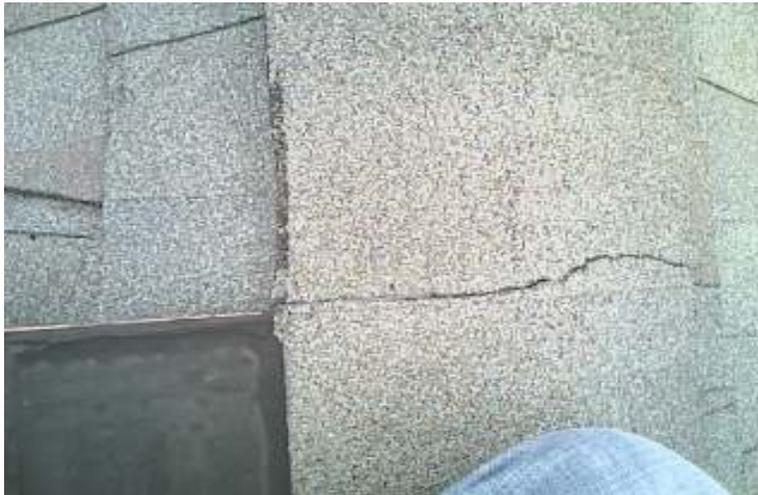
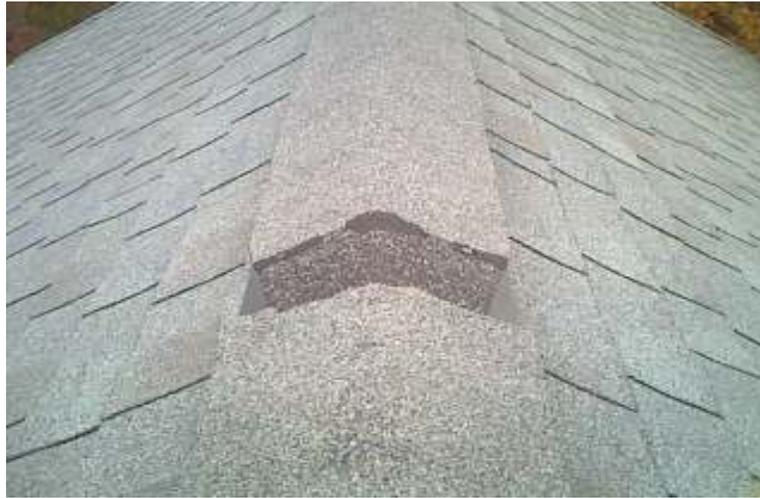
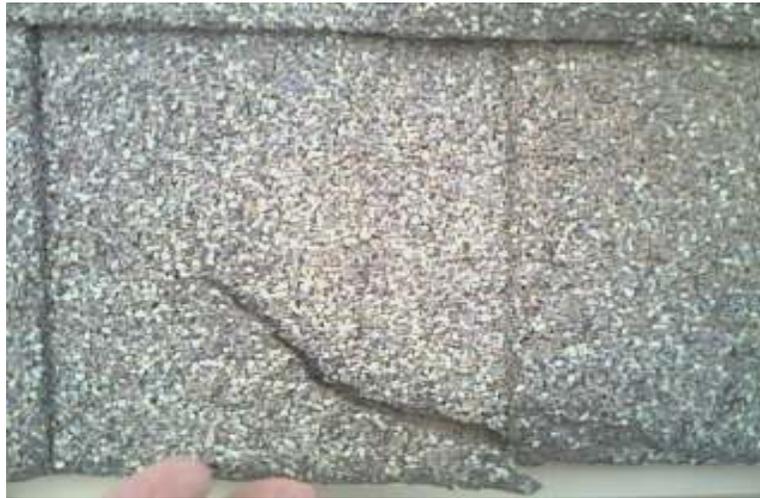
Location: RIDGE CAP

Missing/cracked shingle --- Roof has missing or cracked shingles that should be repaired by a qualified roofing contractor. Water penetration could occur at these areas. Have the contractor further evaluate the roofing system for repairs.

Condition: Missing/cracked shingle - Roof has missing or cracked shingles that should be repaired by a qualified roofing contractor. Water penetration could occur at these areas. Have the contractor further evaluate the roofing system for repairs.

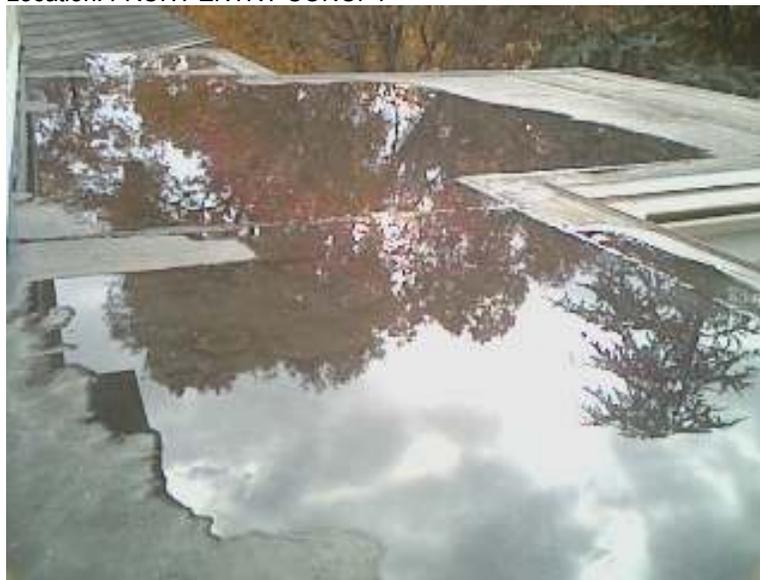
Ponding on roof --- Substantial standing water was observed.
Location: FRONT ENTRY CONOPY

Condition: Ponding on roof - Substantial standing water was observed.

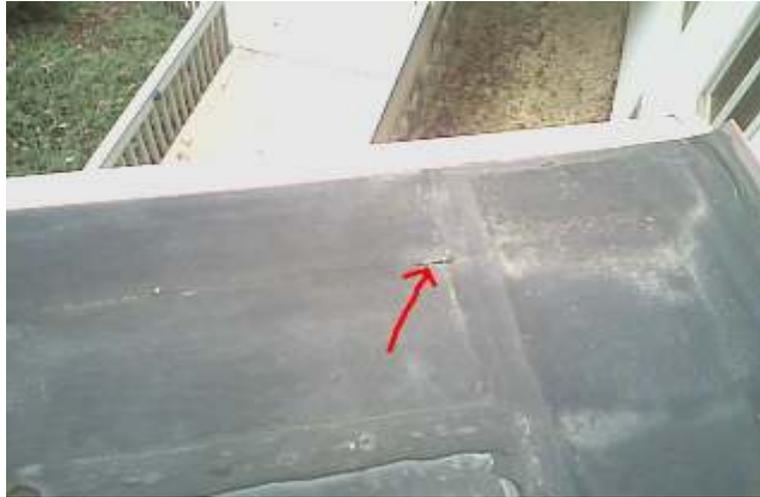
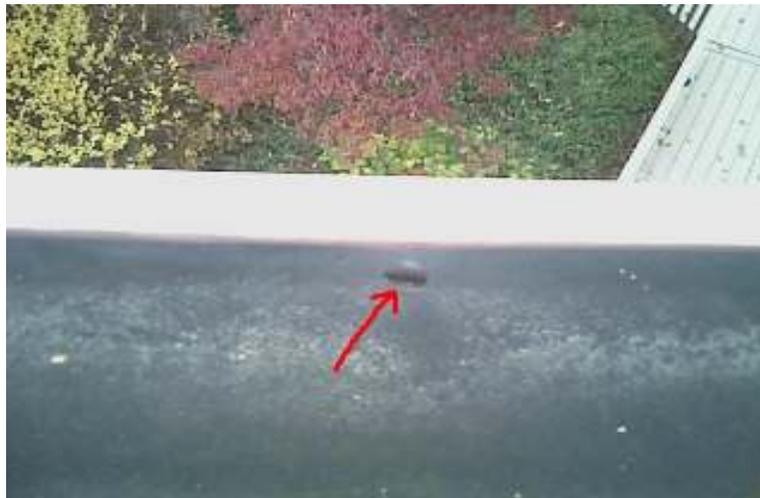
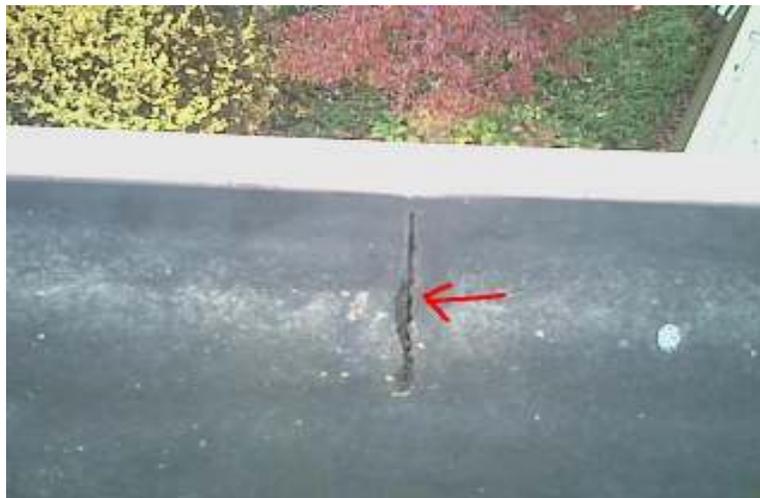
Hole --- A hole was noted which is large enough to require repair.
Location: RUBBER ROOFING

Condition: Hole - A hole was noted which is large enough to require repair.

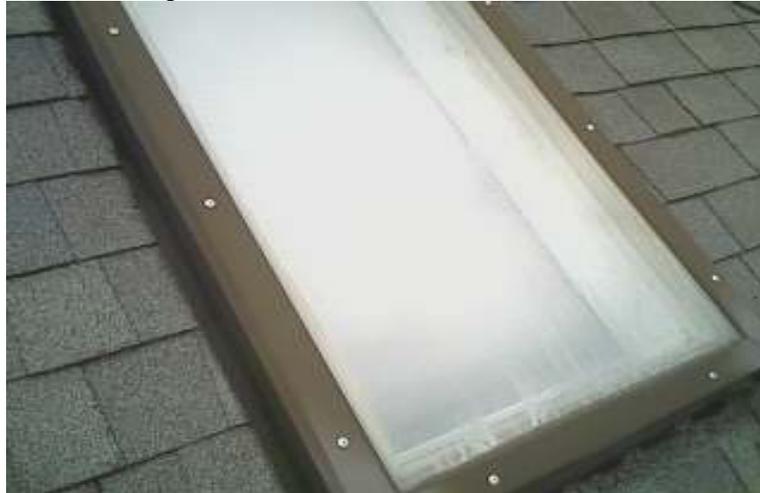
Location: throughout

Conditions: **Fogged** --- Fogging was observed. This indicates failure of the seal between layers of glass. Replacement is the only method to cure this problem.

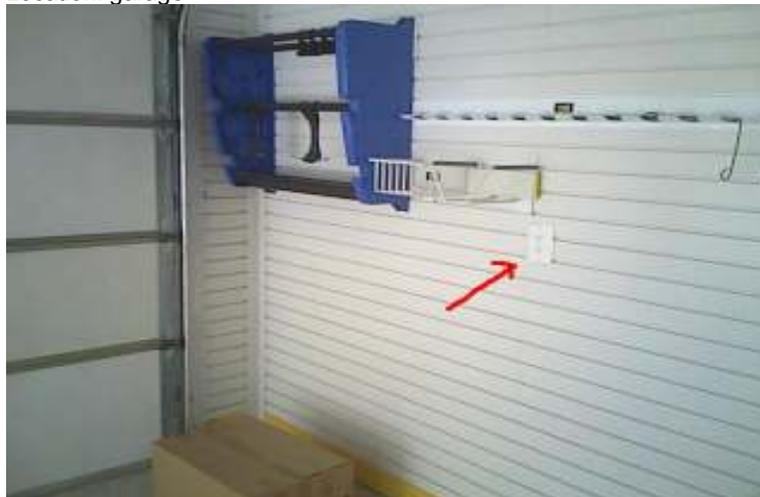
Location: garage

Conditions: **Loose receptacle** --- Electrical receptacle was observed to be loose. The receptacle should be properly reattached in order to prevent a shock hazard.

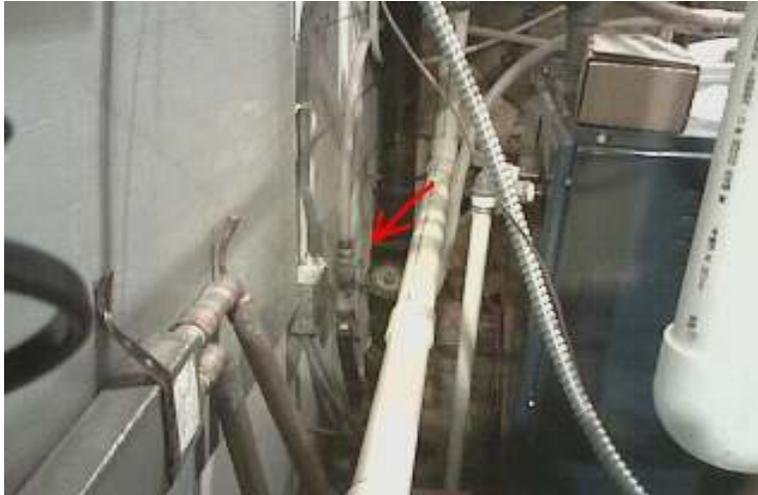
Location: WATER SHUT OFF LOCATION

Conditions: **General Photo ---** General photo of a component or system.

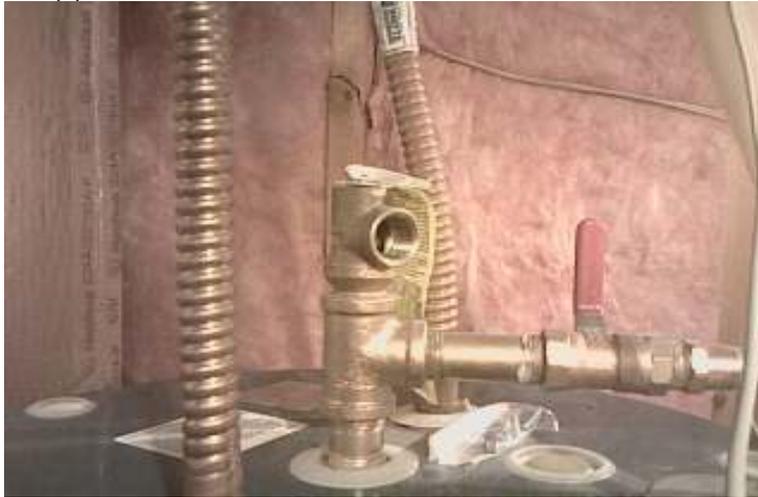
Conditions: **Relief pipe short** --- Temperature/pressure relief valve extension pipe appears to be missing or too short. This pipe should extend to within 6" above floor level.

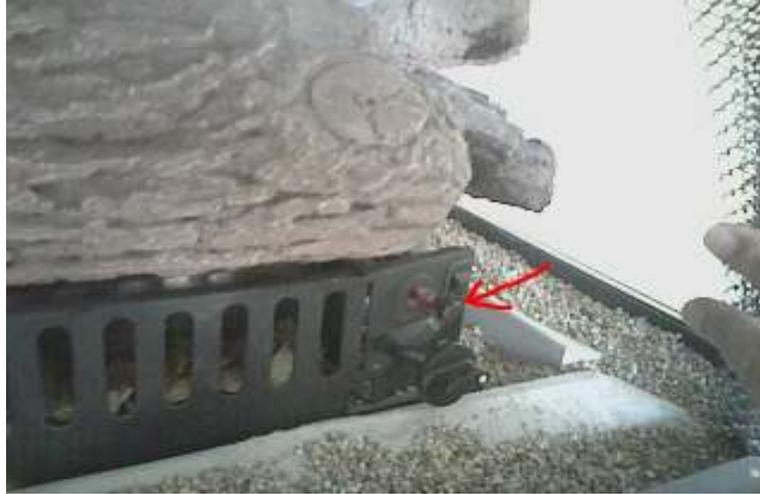
Physical damage --- Physical damage was noted and should be further evaluated and repaired by an appropriate qualified specialist.

Location: Igniter is non-functional.

unable to activate living room fire place.

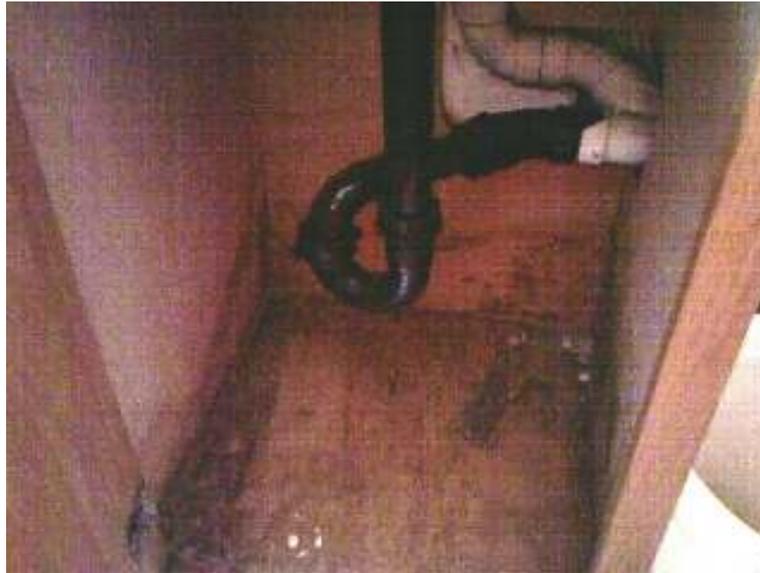
Range:	Electric
Rating:	Satisfactory
Oven:	Electric
Rating:	Satisfactory
Refrigerator:	Double Door
Conditions:	Unplugged --- The unit was unplugged at the time of the inspection and prevented a full examination of the unit. Location: laundry room;
Dishwasher:	Built-in
Rating:	Satisfactory
Microwave:	Built-in
Rating:	Satisfactory
FIXTURES:	The type and condition of the kitchen fixtures is reported in this section.
Sink:	
Conditions:	Water off --- The water was off which prevented the inspector from testing all of the items in the plumbing. Location: cold water to game room sink. Visible mold --- Visible signs of mold were detected from a past or present water or moisture issue. Correct any water issues and have mold remediated by a specialist. Mold can lead to serious health concerns. Location: below game room sink

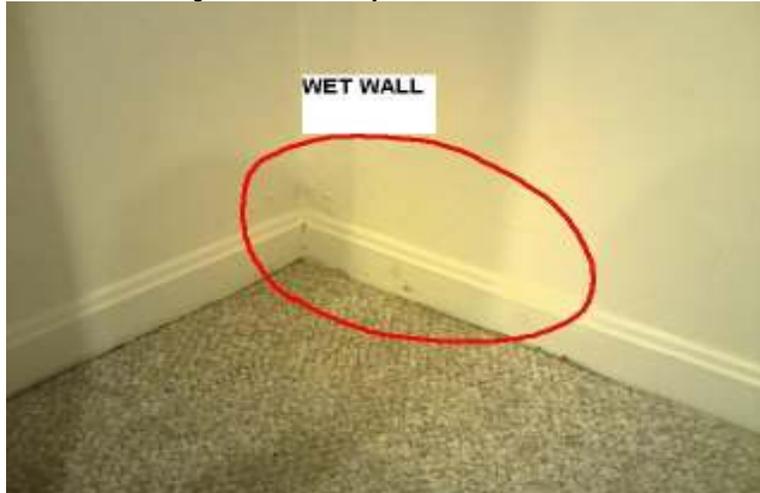
Type: Drywall
Conditions: **Elevated moisture** --- There were elevated moisture readings at the below noted location. Elevated readings could indicate an active moisture concern or raise the likelihood of mold, mildew, and/or dry rot. Determine the source of the moisture and correct.
Location: closet right of sauna entry.

Visible mold --- Visible signs of mold were detected from a past or present water or moisture issue. Correct any water issues and have mold remediated by a specialist. Mold can lead to serious health concerns.
Location: closet right of sauna entry.

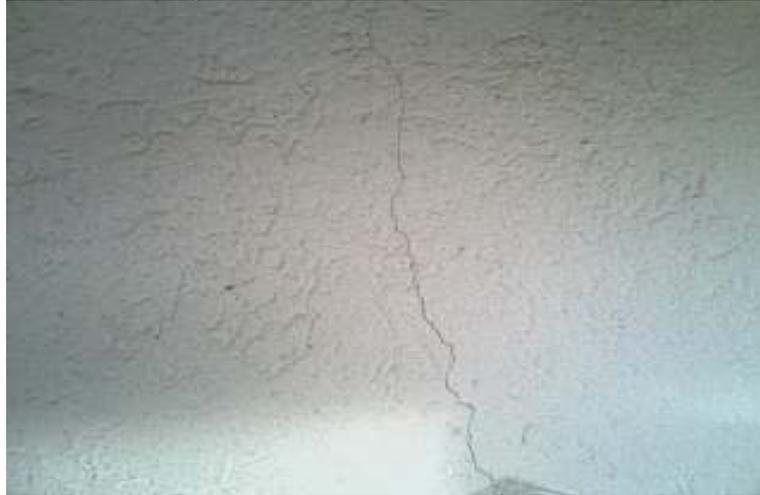
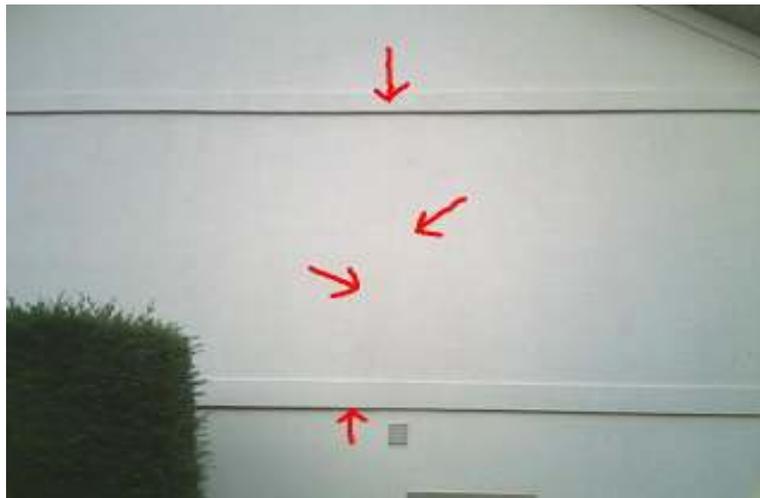
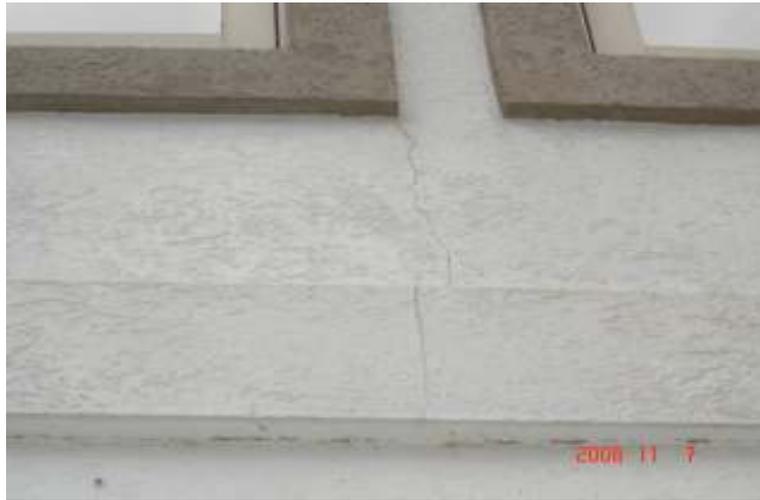
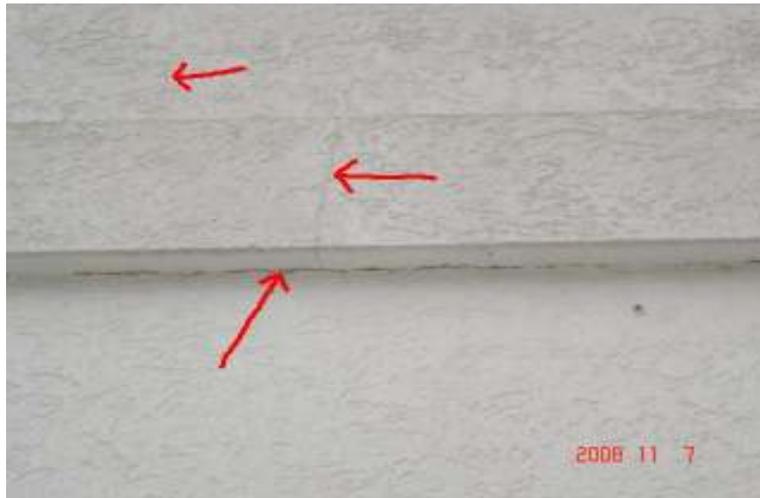
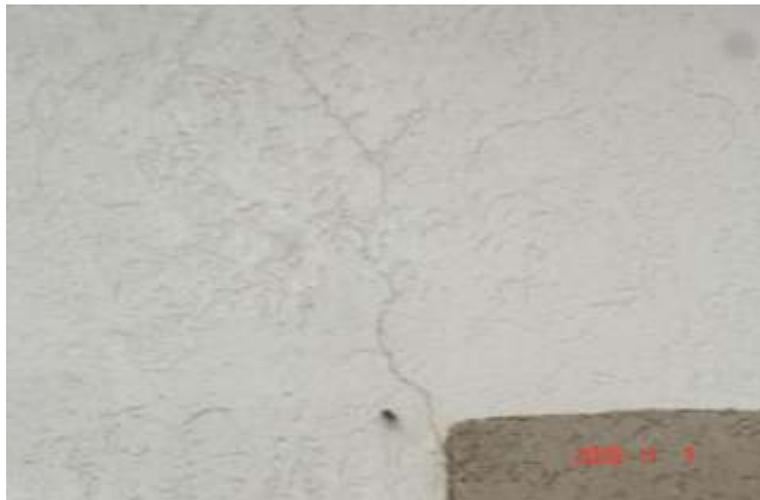
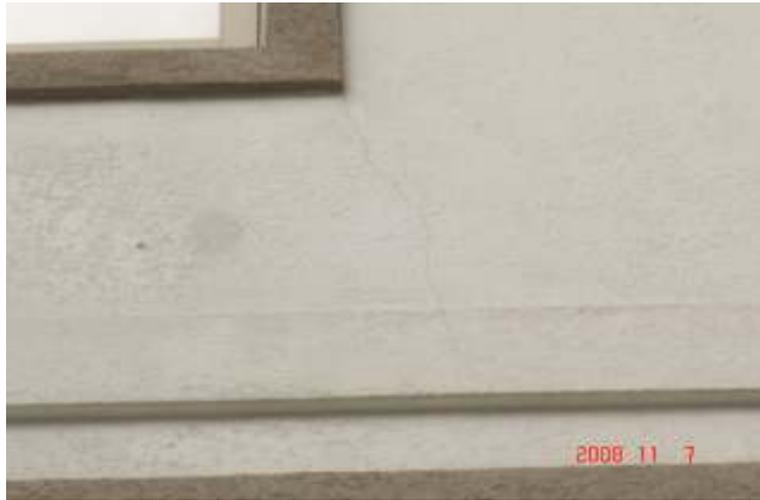
Location: several places

E.I.F.S. crack --- Water penetration is a concern with any crack in the exterior insulation system. Consult with an E.I.F.S. certified specialist for further evaluation of the system and repairs prior to close.

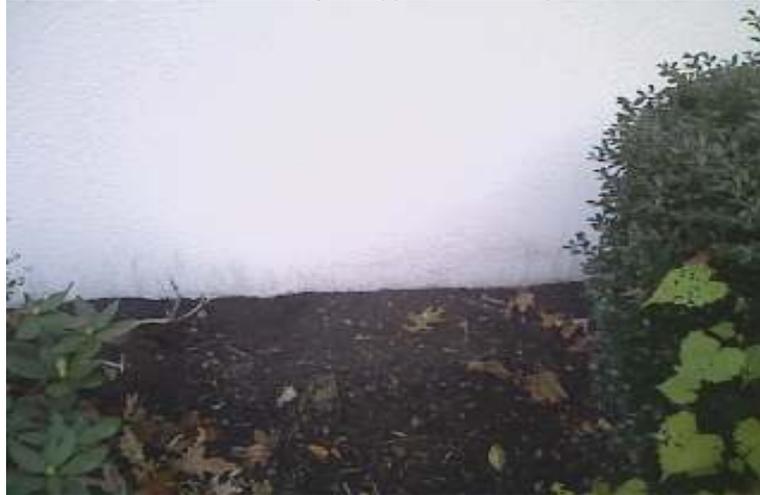
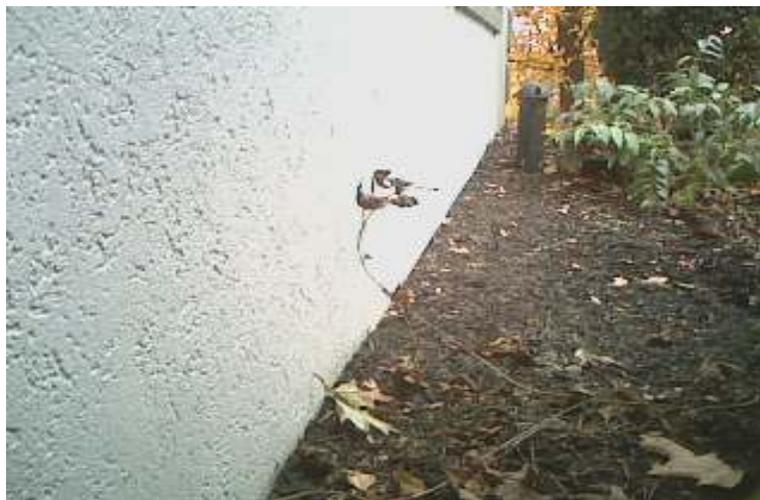
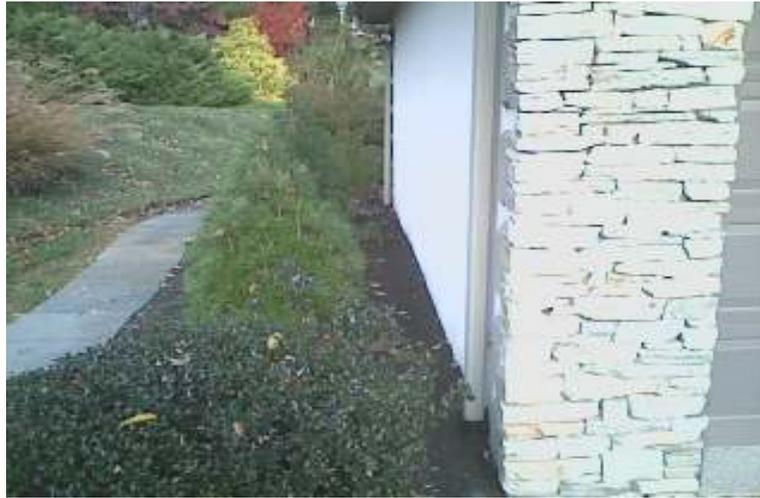
E.I.F.S below grade --- The EIFS siding is contact or below grade and is subject to "wicking", this condition should be further evaluated by an approved EIFS specialist and corrected prior to close.

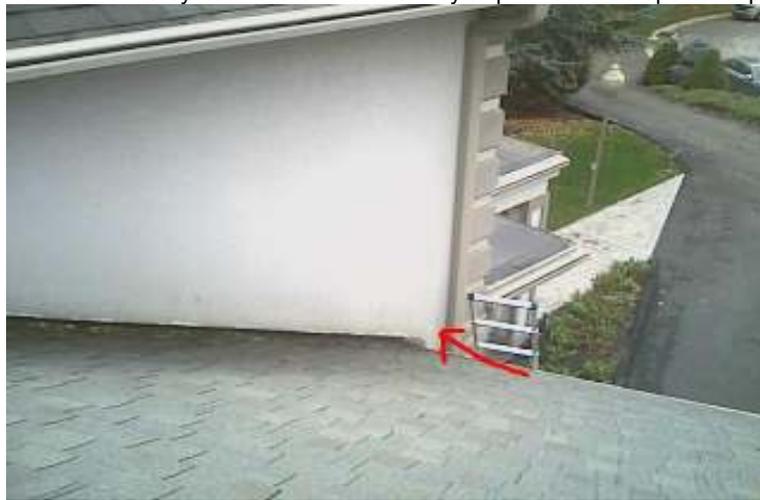
EIFS Loose --- Loose sections of EIFS were observed suggesting insulation separation from the substrate. Have the EIFS system further evaluated by a qualified EIFS specialist prior to close.

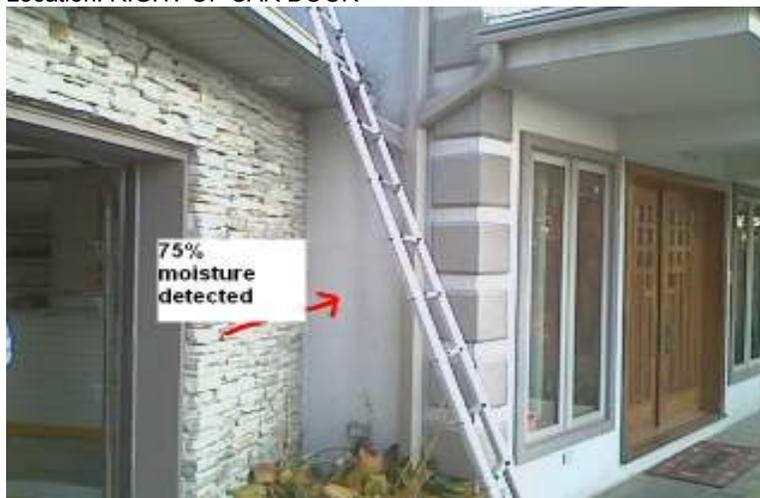
Elevated moisture --- There were elevated moisture readings at the below noted location. Elevated readings could indicate an active moisture concern or raise the likelihood of mold, mildew, and/or dry rot. Determine the source of the moisture and correct.
Location: RIGHT OF CAR DOOR
